# Risk management of structural performance of housing in South Africa

**ABSTRACT:** In South Africa many instances of unacceptable construction quality within the home building industry are apparent throughout the entire spectrum of housing (i.e. low- to high-income). This issue forms one of the main concerns and mandates of the National Home Builders Registration Council (NHBRC). The paper highlights the role of NHBRC, the relevance of risk management and performance based codification and summarises typical structural problems which take place in South African housing. It also presents selected statistics of damage, their socio-economical implications and considers the ways of improving the situation, on the national scale.

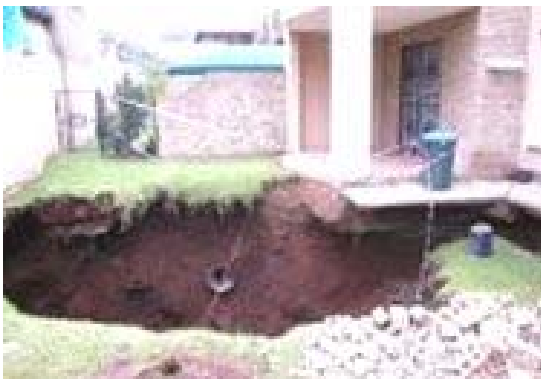
Figure 1. Sinkhole formation on dolomites.

As a result of water infiltration in dolomites sinkholes are formed. A typical sinkhole is presented in Figure 1.

The structural damage and loss of life has been far more severe on dolomites than any other geological formation in South Africa. Dolomites underlie many of the densely populated areas housing approximately 2.5 to 3 million people.

Over the years, many housing developments have been affected by sinkholes, including a case in 1964 in which a house with an entire family of five disappeared in a sinkhole 60m wide and 30m deep.

The design in dolomitic areas requires initial identification of the risk category. Dolomite land is classified into three categories: low, medium and high risk (with only the low and medium risk land being suitable for residential development). This has to be preceded by a detailed dolomitic stability and geotechnical investigation. The water, sewer and stormwater services must be designed in a way to minimize the water infiltration into the soil.

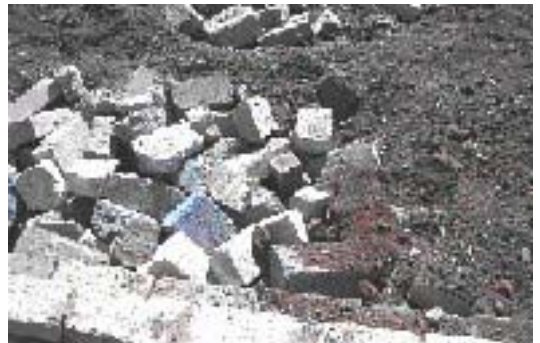
Figure 2. In-fill of a foundation.

The substructure problems typically relate to inappropriate design solution, poor materials and / or lack of adherence to prescribed minima standards. An example of such situation is presented in Figure 2, in which broken bricks are used for an in-fill.

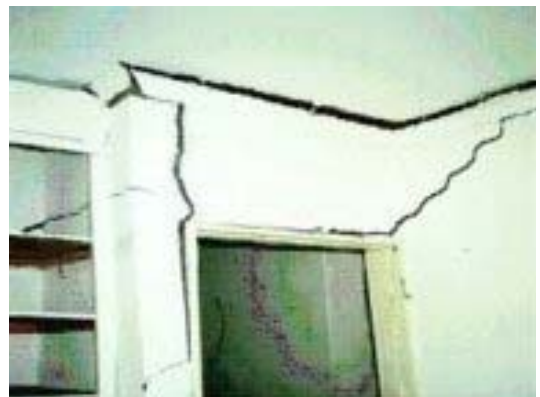
Figure 2. Failure of super-structure.

The failure of superstructure typically refers to cracking and / or collapse of walls. An example of severely cracked walls is presented in Figure 2.

The failures of super-structures result from poor workmanship use of inappropriate material and technologies and lack of appropriate attention given to structural detailing (e.g. connections of external and internal walls, inadequate provision of lintels above large openings, presence of large unsupported sections of walls). The failure may also be triggered by failure of the foundation systems.

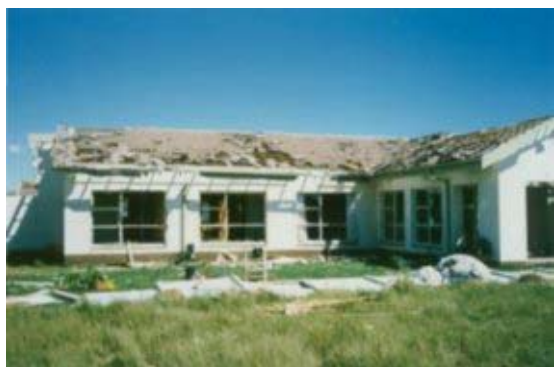
Figure 3. Damage to tiles and glazing.

The air-tightness is related to the porosity of cladding (i.e. the type of material used) which can largely affect the extent of damage to roofs. For example under severe wind conditions, selected roof tiles may be displaced and broken (see Figure 3). On the other hand under similar wind conditions entire corrugated sheeting might be pulled off, or in extreme cases roof structure can also be damaged or displaced (Figure 4).

The structural damage to roofs typically results from wind action. The wind loads generated on roofs of houses depend on their geometrical form and air-tightness (i.e. the ability of pressure equalization). Most vulnerable are roofs with small slopes (so-called flat-roofs) as opposed those with steep slopes (pitched roofs).
